Illinois Environmental Protection Agency

Date: October 19, 1993
To: Division of Land Pollution Control, Division File
From: Rich Johnson^{RJ}, DLPC/FOS, Springfield Region
Subject: LPC1358070001--Montgomery County
Hillsboro/Eagle Zinc
ILD980606941
FOS

Background Information

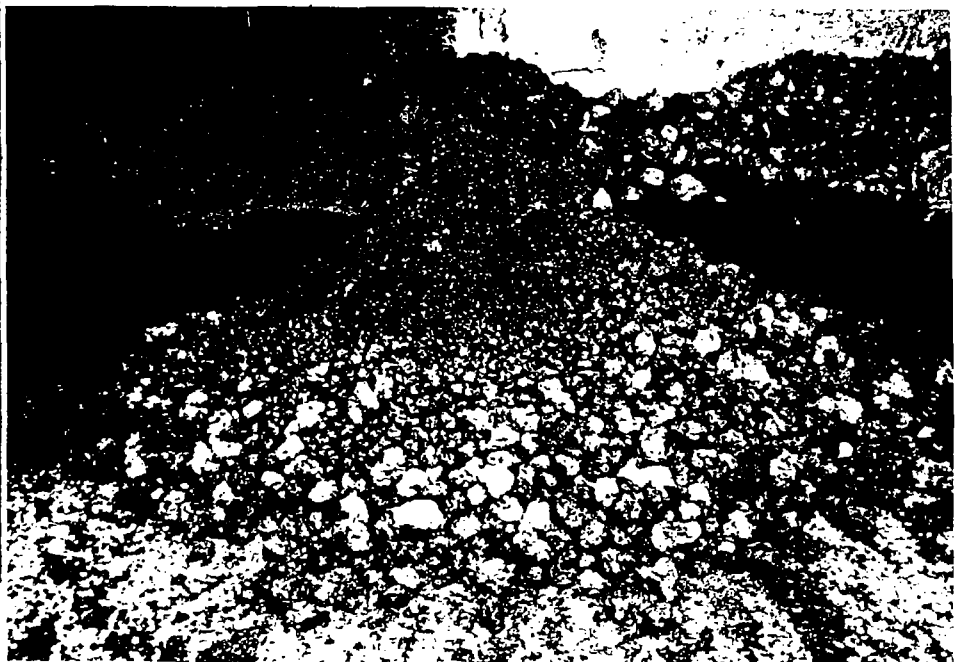
Mr. Youngless called the material that comes out of the furnaces as furnace residues. Furnace residues from Block 2 were black in appearance (see photos 1 and 2 of Roll 451) with some of it granular and some as large as a baseballs. Mr. Youngless said the residue will eventually be processed to recover the carbon. Mr. Youngless indicated the plant has a Carbon Recovery Building to remove coal (which contains carbon) from the furnace residue. Coal was said to be separated from the heavier furnace residue by using screens of different sizes and water. The left over heavier material was called furnace tailings by Mr. Youngless. He said even the tailings had some worth because they contain a certain amount of zinc and copper. However, the tailings can not be re-used on-site. According to Mr. Youngless, it has been years since any tailings have been sold off-site. Mr. Youngless indicated that no recent effort to sell the tailings has been made because the price of zinc was so low on the metal markets. He attributed part of the recent low prices to the glut of metals coming into the market from the former Soviet Union. In a letter dated March 11, 1991, Mr. Youngless indicated that Eagle Zinc does not operate an on-site landfill. Mr. Youngless had said during the inspection that he did not view the furnace residues or tailings as waste since they can be reused or reclaimed.

DATE: <u>7/15/93</u>
TIME: <u>10:15AM-5:09PM</u>
PHOTOGRAPH TAKEN BY: <u>Rich Johnson</u>
COMMENTS: Pictures taken toward: <u>the south</u>
<u>from the north</u>
<u>of "Block 2" furnace</u>
<u>bdg.</u>
ROLL #: <u>451</u> Neg. #: <u>2</u>

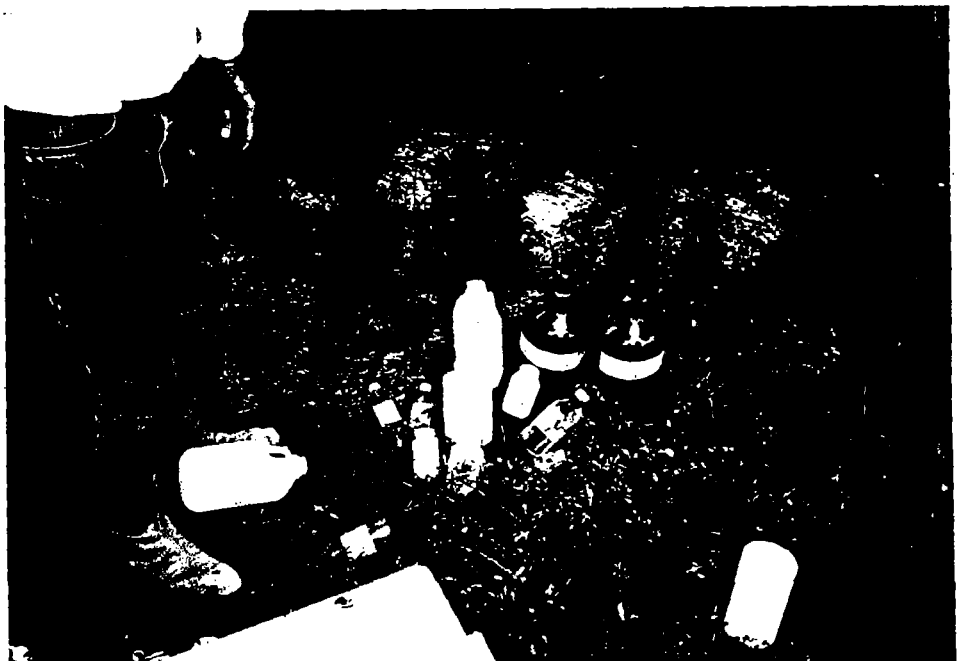
(S301) was taken from water (see photo 18 of Roll 452) that exited a pond located in the southwest corner of the property (see photos 15 and 16 of Roll 452). Water discharges from a break in the west wall of the pond (see photo 17 from Roll 452) and flows to a tributary of Shoal Creek. The pond receives water from a low marshy area to the east. Mr. Wells walked upstream of the low area to try to find the source of the water. He indicated that the flow of water went around a concrete wall standing by itself northeast of the pond. The second sample of water (S101) was collected in the low marshy area northeast of the pond (see photo 19 of Roll 452). The last water sample (S302) was taken from a stream exiting the eastern boundary of Eagle Zinc (see photo 20 of Roll 452). The stream flows under a public road and continues eastward where it apparently empties to Hillsboro Lake.

DATE: <u>7/15/93</u>
TIME: <u>10:15AM-5:09PM</u>
PHOTOGRAPH TAKEN BY: <u>Rich Johnson</u>
COMMENTS: Pictures taken toward: <u>the west from</u> <u>the southwest</u> <u>region of the</u> <u>property - photo</u> <u>of S301</u>
ROLL #: <u>452</u> Neg. #: <u>18</u>

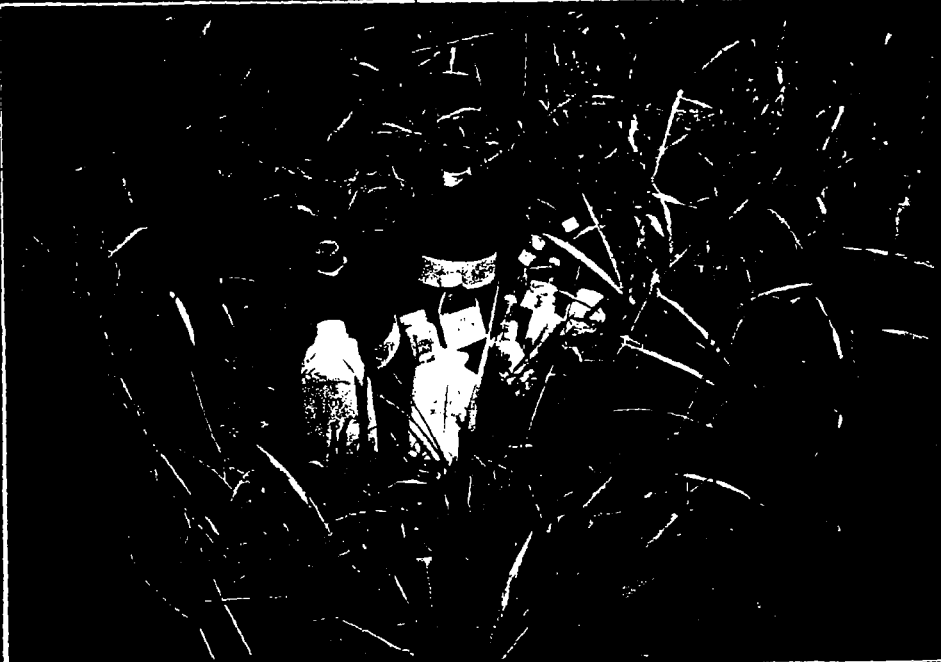
COMMENTS: Pictures taken toward: <u>the north</u>	
<u>from the southern</u>	
<u>region of the</u>	
<u>property. - photo</u>	
<u>of S101.</u>	
ROLL #: <u>452</u> Neg. #: <u>19</u>

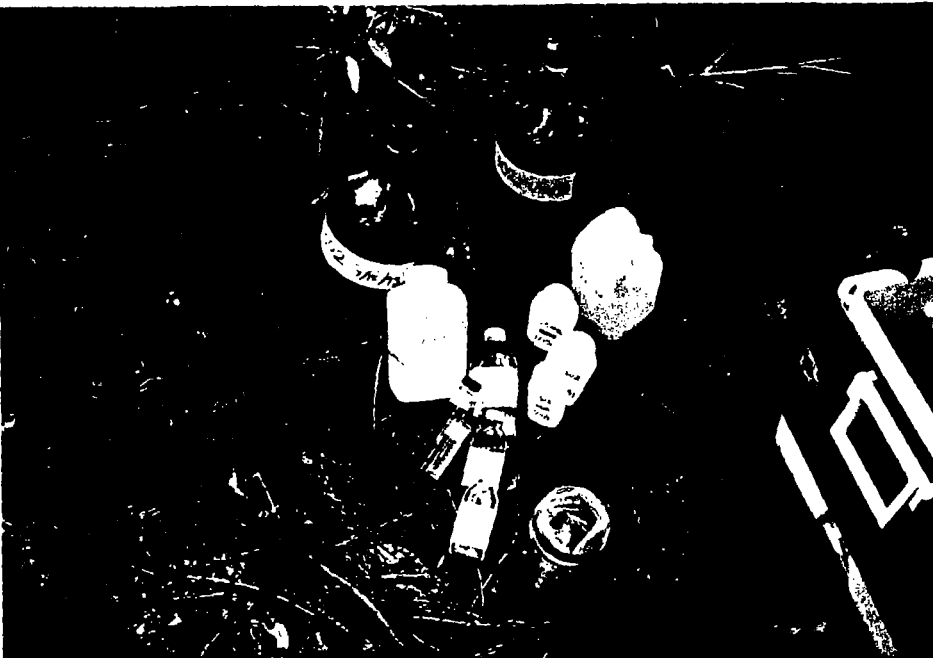
TIME: <u>10:15AM-5:09PM</u>	
PHOTOGRAPH TAKEN BY: <u>Rich Johnson</u>	
COMMENTS: Pictures taken toward: <u>the southeast</u>	
<u>from the east</u>	
<u>side of the</u>	
<u>property. - photo</u>	
<u>of S302</u>	
ROLL #: <u>452</u> Neg. #: <u>20</u>
